# Analysis of Three UH-60 Blackhawk Servolink Components P/N 70400-08110-061

ARL-TR-2646

# Army Research Laboratory

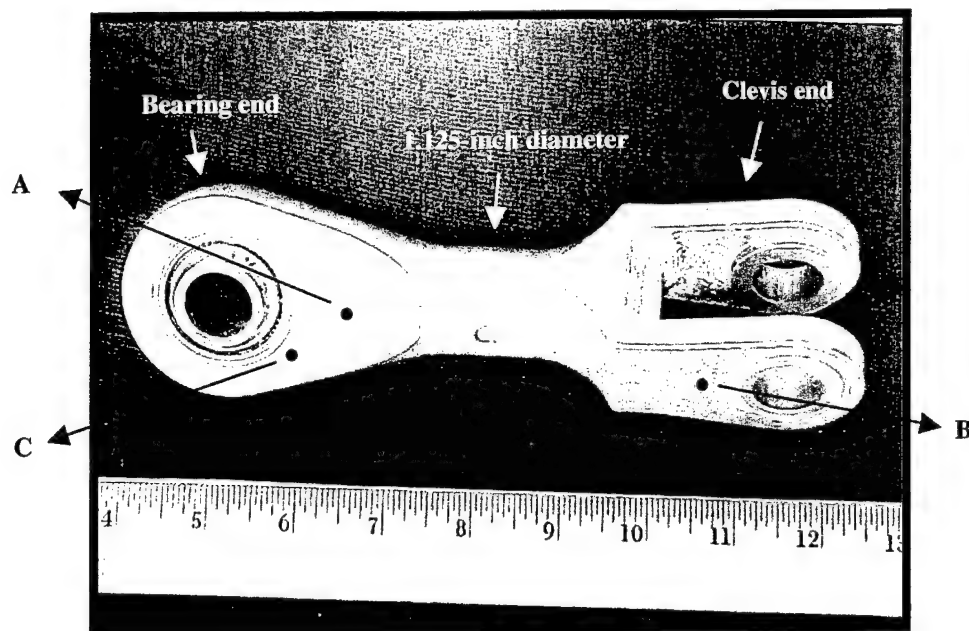
Figure 1. As-received UH-60 servolink S/N 02168. The labeling is included for clarification throughout the context of the report. Locations A, B, C, and D were areas of residual stress measurement (see Table 2). Reduced ~50%.

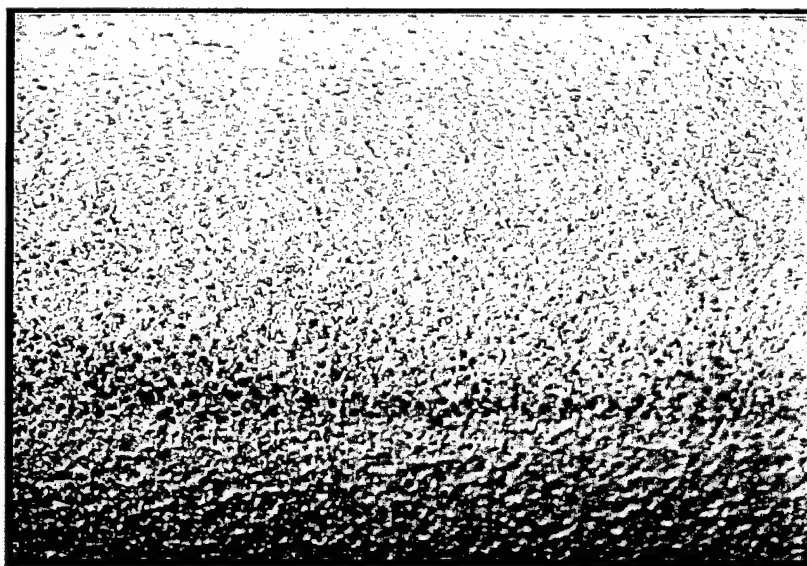
Figure 2. Macrograph representative of the "well-pronounced shot-peening dimples." Magnification 11.75x.

To the unaided eye, the parts appeared to have a non-uniform shot-peened surface; in other words, some regions appeared to have a more pronounced dimpled topography than other regions. In general, the 1.125-in diameter exhibited the most pronounced dimples, while the region adjacent to the bearing raceway contained less pronounced dimples. However, as Figures 2 and 3 show, each of the areas was indeed shot peened, and they contained dimples. Figures 4 and 5 show these representative areas at higher magnification. Each servolink showed evidence of peening on the entire outer surface.

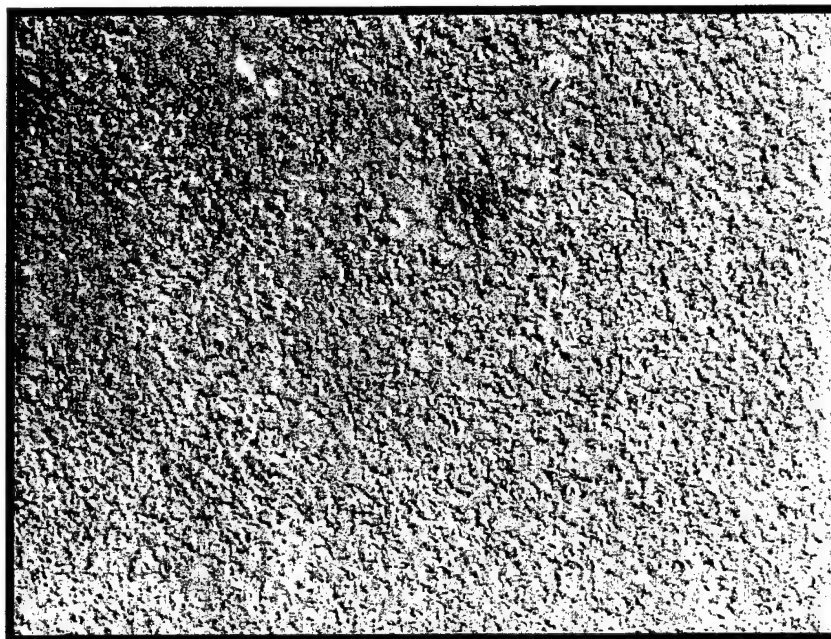
Figure 3. Macrograph representative of the "fine dimples." Also note regions appear less dimpled. Magnification 11.75 $\times$ .

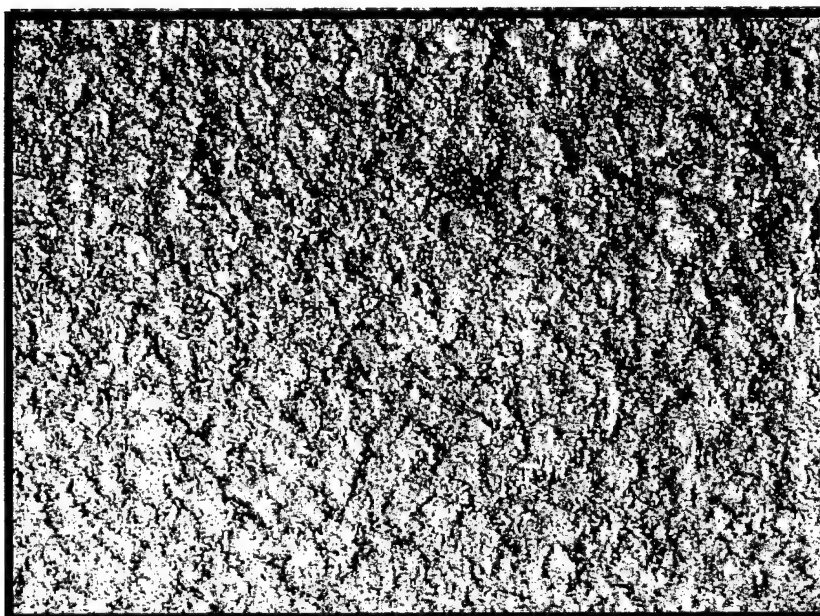
Figure 4. Magnified view of Figure 2 ("well-pronounced shot-peening dimples"). Magnification 56 $\times$ .

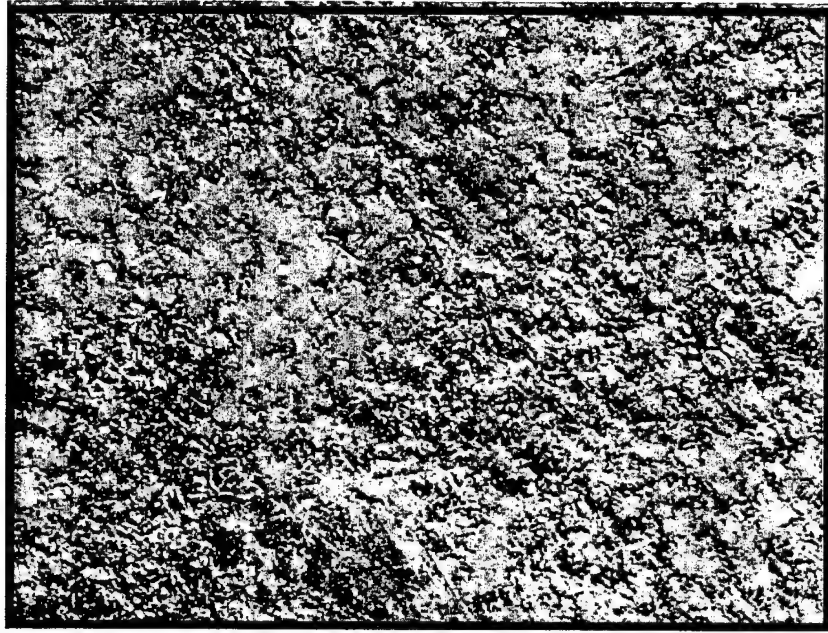
Figure 5. Magnified view of Figure 3 ("fine dimples"). Note the regions that appear less dimpled. Magnification 56 $\times$ .

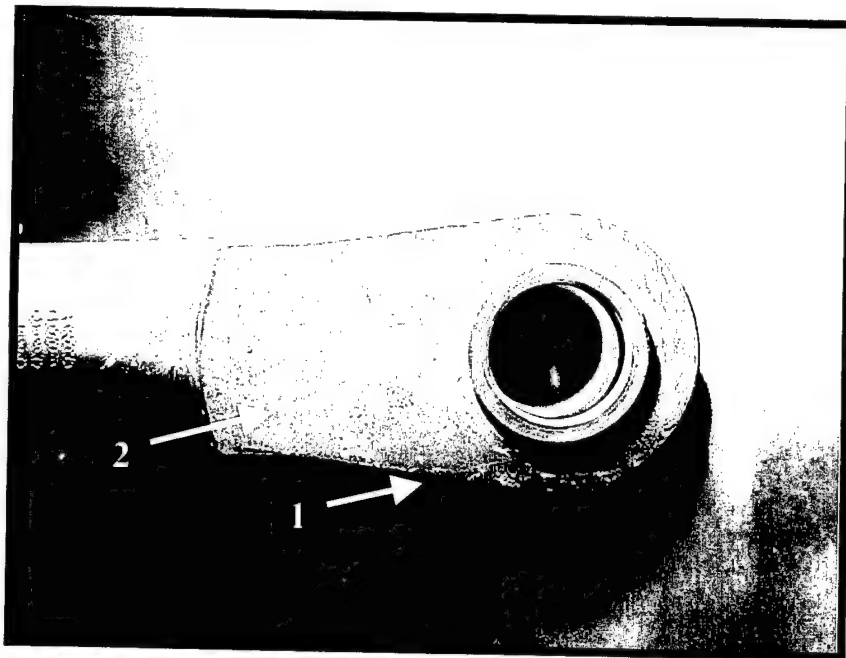
Stereoscopic examination was utilized to determine whether the surface scratches observed on the components were induced prior to or after the peening operation. Figure 6 shows two of the larger scratches noted on the surface of servolink 02168, labeled as 1 and 2. Scratches 1 and 2 are shown in Figures 7 and 8 under higher magnification. Further magnification was necessary to determine whether the scratches were present prior to or after the peening process. Figures 9 and 10 show the scratches at a magnification suitable for such an analysis. From these figures, it is clear that the scratches were present prior to peening. This conclusion was drawn based upon the amount of deformation around the scratch caused by the dimpling of the shot impacts. This was generally the case with many of the scratches observed; however, there were groups of scratches found on both the 01266 and 01268 servolinks adjacent to the

Figure 6. Clevis end of servolink 02168 showing two of the many scratches (1 and 2 as shown with arrows). Magnification 1 $\times$ .

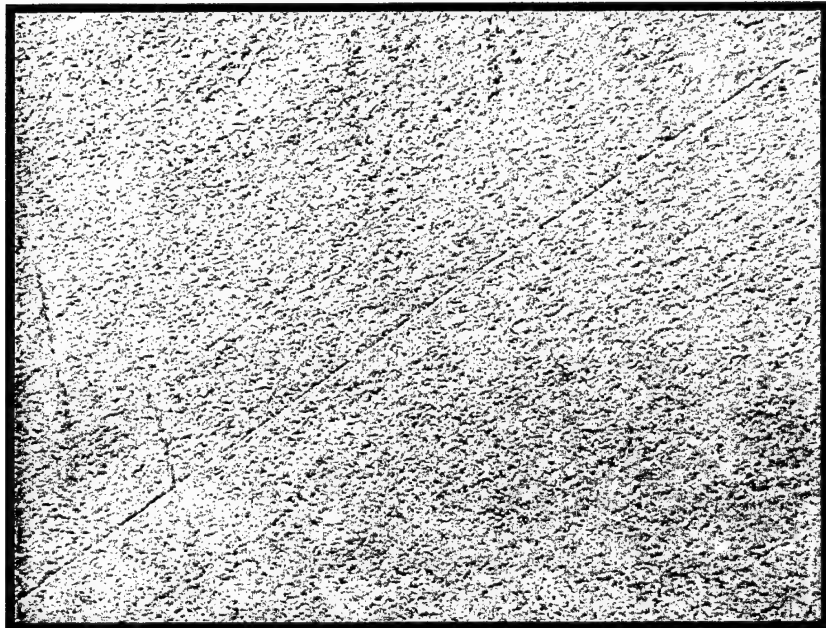
Figure 8. Scratch 2 at higher magnification. Magnification 11.75x.

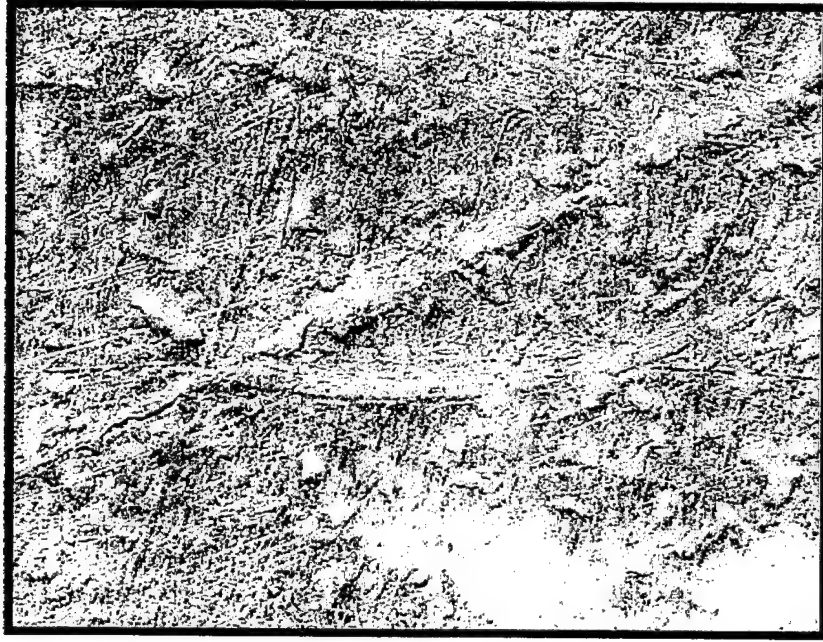
Figure 9. Scratch 1 at further higher magnification showing the effect of being shot peened. Magnification 56 $\times$ .

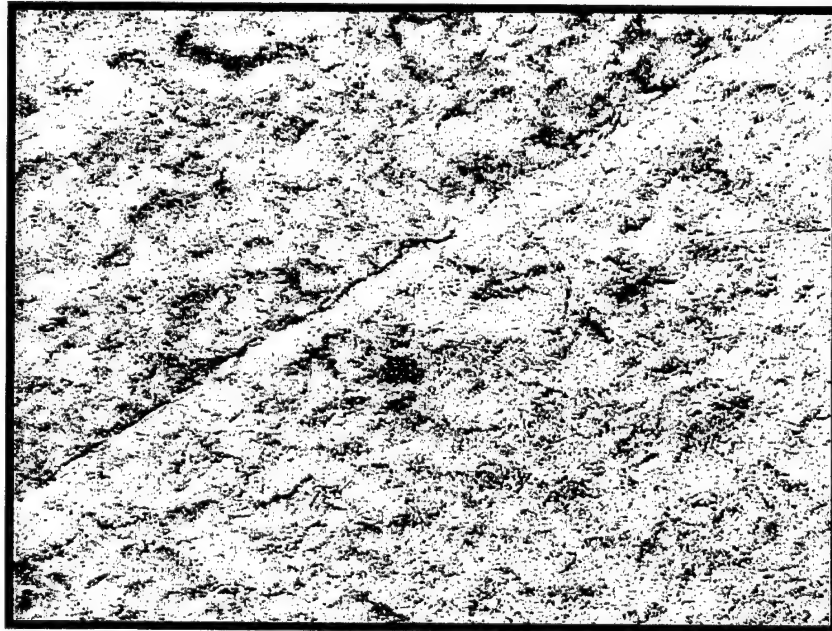
Figure 10. Scratch 2 at further higher magnification showing effect of being shot peened. Magnification 56 $\times$ .

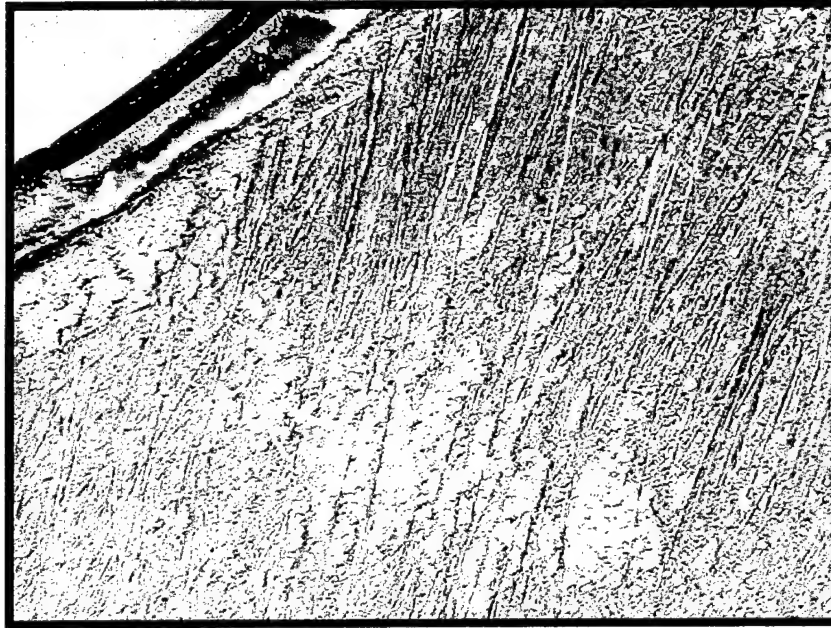
bearing where this was not the case. Figures 11 and 12 show this area at low magnification. At higher magnification (Figures 13 and 14), the scratches did not appear to be deformed by the peening operation. In fact, the scratches seemed to smear the peened dimples such as to eliminate evidence of prior peening. Upon closer examination, however, peened dimples could be observed distributed sporadically among the scratches. Aside from these localized areas, ARL did not find evidence of any other scratches induced after the peening process.

Figure 11. Scratches adjacent to the bearing on servolink 01266. Magnification 11.75 $\times$ .

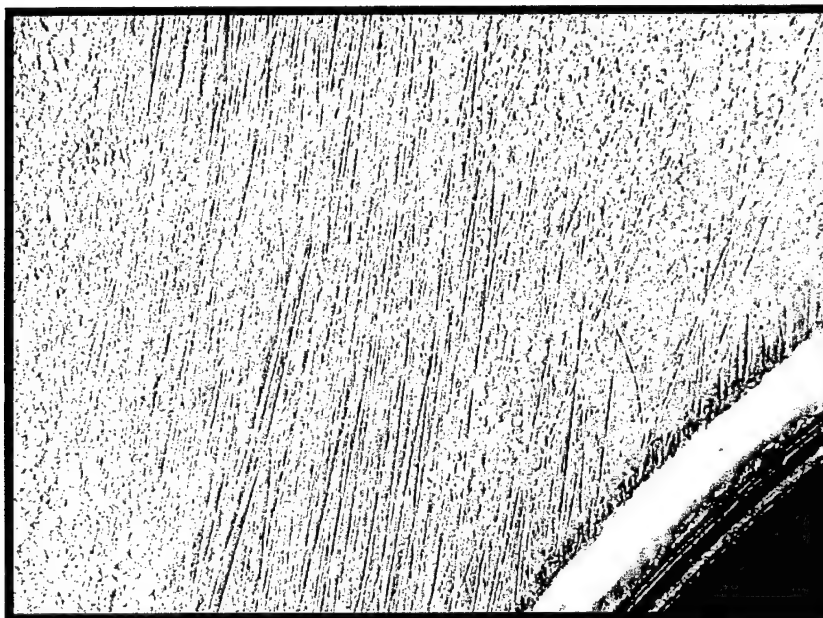
Figure 12. Scratches adjacent to the bearing on servolink 01268. Magnification 11.75 $\times$ .

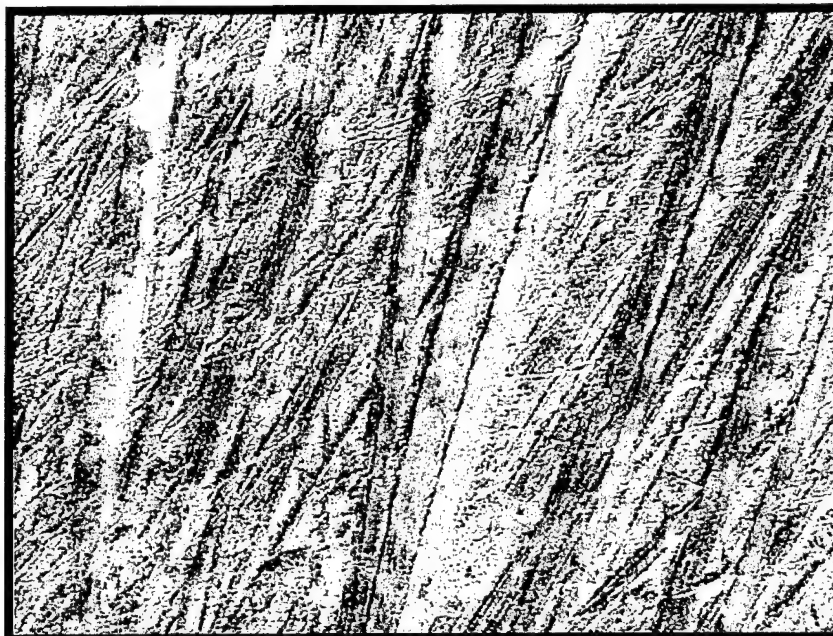
Figure 13. Scratches adjacent to the bearing on servolink 01266 at higher magnification. These scratches did not appear to have been shot peened. Magnification 56 $\times$ .

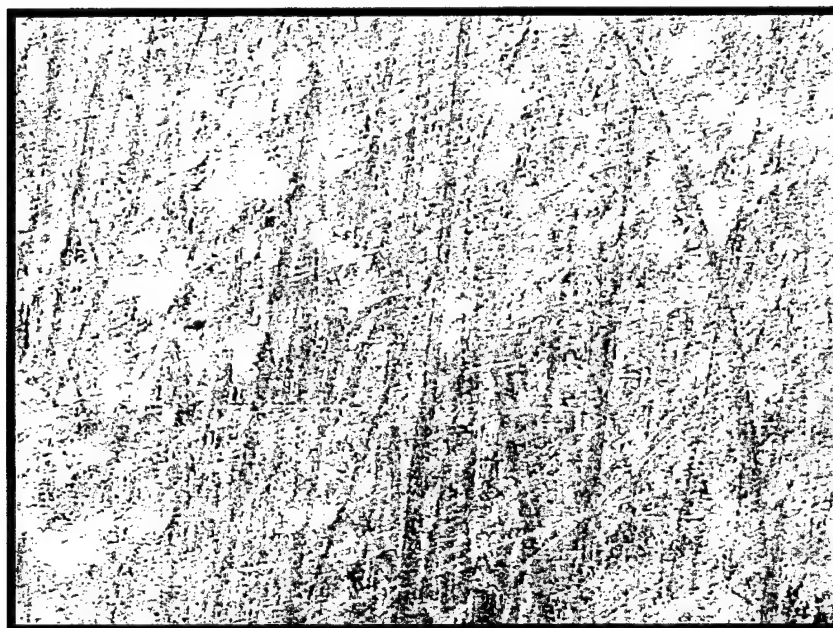
Figure 14. Scratches adjacent to the bearing on servolink 01268 at higher magnification. These scratches did not appear to have been shot peened. Magnification 56 $\times$ .

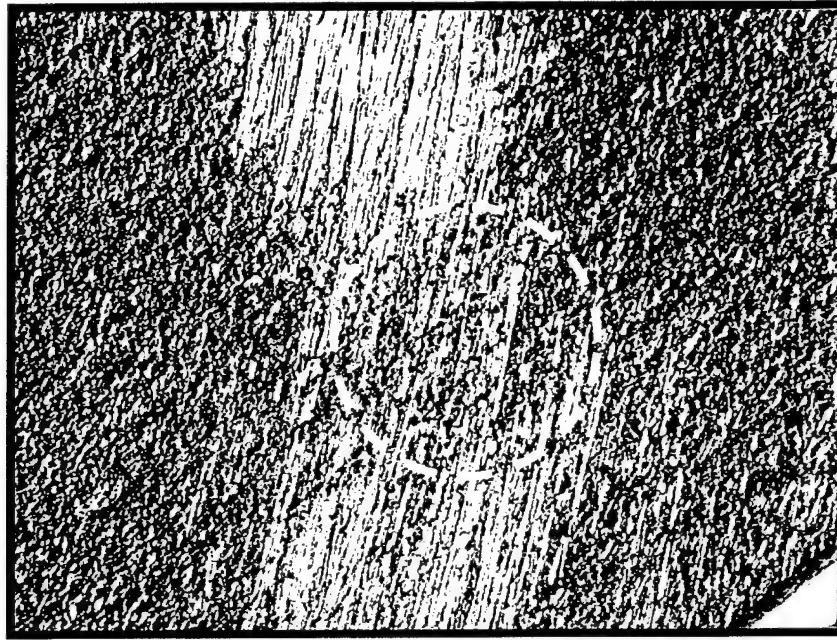
Figure 15. Macrograph showing the location of residual stress measurement within a heavily scratched area. Circle shows approximate location of residual stress depth measurements. Magnification 11.75 $\times$ .

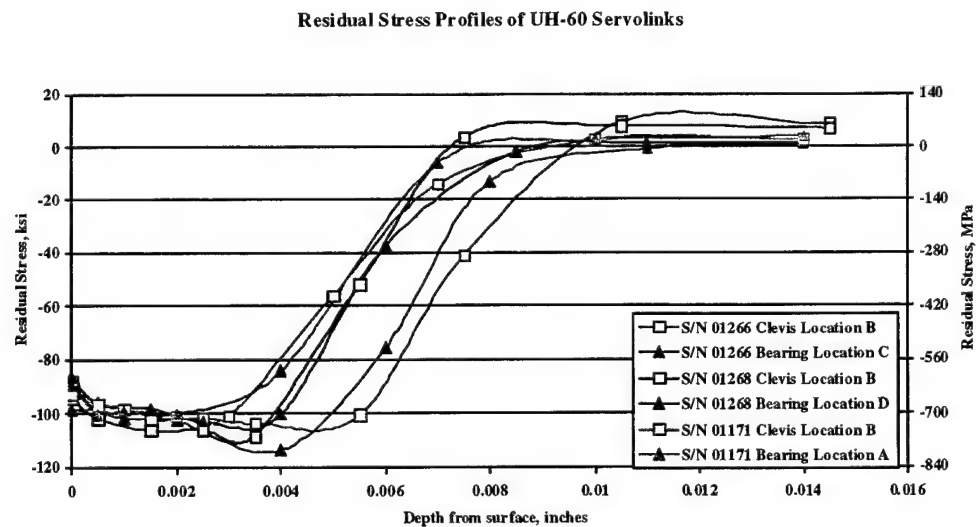
The observed (measured) surface and subsurface residual stress and stress error, measurement location and direction, and the x-ray diffraction peak width data acquired during this investigation are listed in Table 2. The residual stress data was subsequently corrected for the differences in the depths penetrated by the x-ray beam, for subsurface stress gradients, and for stress relaxation resulting from material removal by electropolishing. The x-ray peak full-width half-maximum (FWHM), or line broadening, data reported in degrees was obtained at the  $\psi = 0^\circ$  angular position. This supplemental residual stress analysis information can be used as a qualitative assessment of process-induced cold work into the material (e.g., from shot peening). Included in the Appendices are the depth analysis reports and the individual plots of true (corrected) residual stress vs. depth from the surface for the two locations each measured on the three servolinks. Figure 15 shows an example of the location of surface residual stress measurements on a heavily scratched area. The circle denotes the irradiated area (3-mm diameter). A plot of these six depth profiles is presented in Figure 16.

Compressive residual stress was measured on the surface of the servolinks after dissolving away the cadmium plating. Measurements were performed at locations without scratches as well as on or adjacent to heavily scratched areas. These surface stresses averaged  $-91.5 \pm 4.5$  ksi ( $-631 \pm 31$  MPa) and *indicate that the scratches had little or no effect on the prior shot peening-induced residual stress*. From just beneath the surface to a depth of approximately 0.004 in (0.102 mm), a fairly uniform compressive stress averaging -101 ksi (-696 MPa) was measured. Below the 0.004-in (0.102-mm) depth, a steep stress gradient extending to approximately 0.008 in (0.203 mm) was observed in which the residual stress magnitude decreases from the maximum compressive stress measured to zero or slightly tensile. These latter residual stress levels are consistent to the final electropolished depth of approximately 0.014 in (0.356 mm). The clevis end and bearing end residual stress depth profiles for servolinks 01171 and 01268 are reasonably uniform in all respects, including the magnitude and depth of the maximum compressive stress and the total depth of the compressive layer. On servolink 01266, however, the maximum compressive stress was measured at an approximately 0.002 in (0.051 mm) deeper layer than on servolinks 01171 and 01268. Additionally, the clevis end depth profile lies to the right of the bearing end profile (on Figure 16) indicating that the beneficial compressive residual stresses extend deeper into the component.

Figure 16. A plot of the six depth profiles representing corrected residual stress vs. depth for the two readings on each of the three servolinks measured.
